Škoda Rapid Spaceback 2013→

PU Side Mouldings

F-46

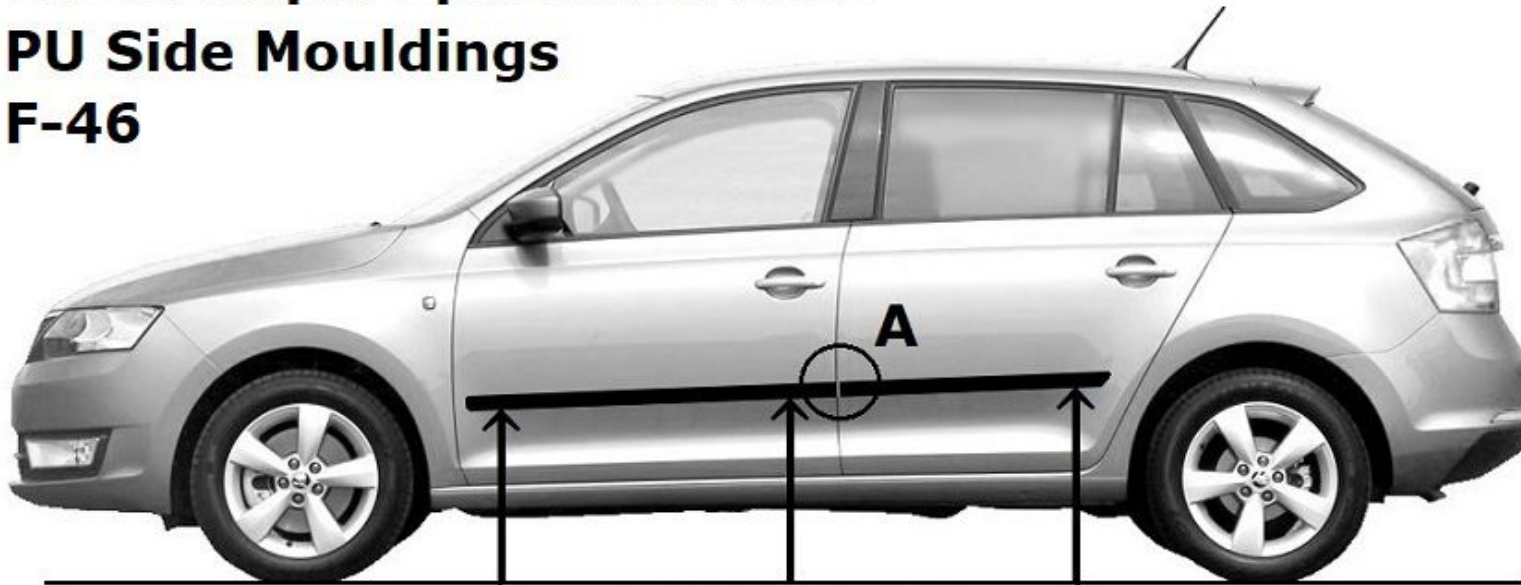
nad przetłoczeniem
over the line
über dem Strich

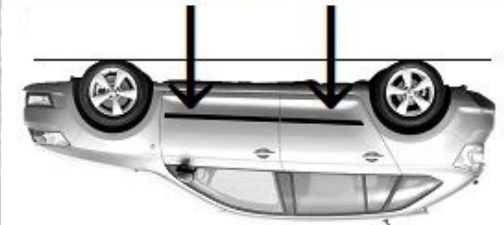
RH FRONT RH REAR

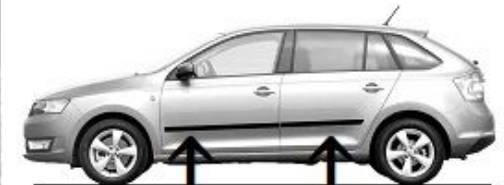
← FRONT

LH FRONT LH REAR

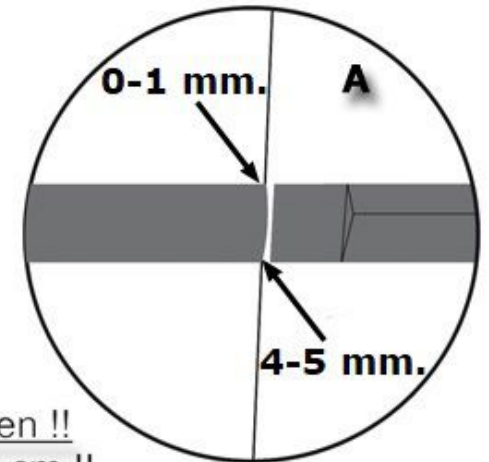
A

0-1 mm.

4-5 mm.
